REPORT NO: NAWCADPAX/TR-2002/94

TESTING CONDUCTED ON WALL-HANGING TROOP SEATS

SUMMARY

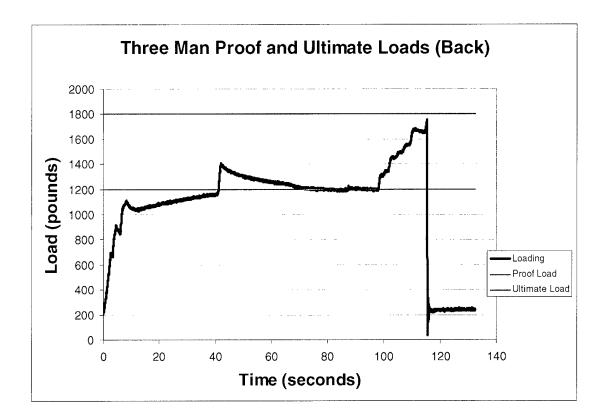
Figure 10: Data Collected during Back Loading Test

The first test conducted was a back test. Prior to attaching the seat to the Static Test Fixture, the weight of the seat was exactly 5 lb. This test used the three-man pressure foot. The proof load of 1,200 lb was first applied for 60 sec. Prior to reaching the proof load, at approximately 914 lb, the right leg of the seat came free from the bottom plate. Since there was no ripping or failure of the legs or spreader bar, the test continued. Other than the leg coming free, there was no deformation of the seat and no failure. Next, the ultimate load of 1,800 lb was applied. Prior to reaching the ultimate load, at 1,754 lb, the fabric from under the front tube on the left side came free. The fabric did not rip, and the screws did not come loose. The left most tiedown hook came free from the upper attachment, but did not deform or fail. Photographs of the failure are shown in figures 6 through 9. The graph created from the downloaded data is shown below in figure 10. All still photographs that were taken are shown in appendix B.

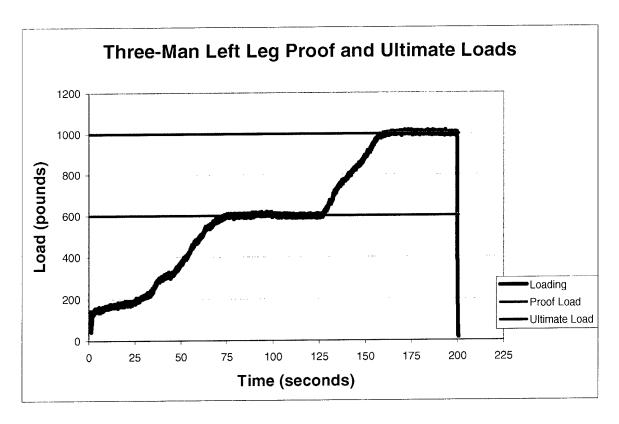
Figure 11: Data Collected during Testing of Left Leg

After examination of the right leg of the first seat tested, no damage was found on the bottom plate or on the locking mechanism of the leg. It was decided to test the legs next to ascertain that the legs could withstand the proof and ultimate loads and to see if the legs would pull apart from the bottom plate again. This involved removing both legs from the Newgard seat. The legs each weighed 0.75 lb. The left leg was tested first. The proof load of 600 lb was first applied and held for 60 sec. No deformation of the leg was seen. The ultimate load of 1,000 lb was then applied and held for 60 sec. Again, no deformation of the leg was seen. After testing, the leg was removed and measured. No elongation of the leg had occurred during testing, and all locking devices at the bottom of the leg were undamaged. The graph created from the downloaded data is shown below in figure 11. The still photographs taken are available in appendix B. The right leg was tested next. The procedure followed for the left leg was followed for the right leg. The right leg did not deform or fail. The graph created from the downloaded data is shown in figure 12, and all still photographs are available in appendix B.

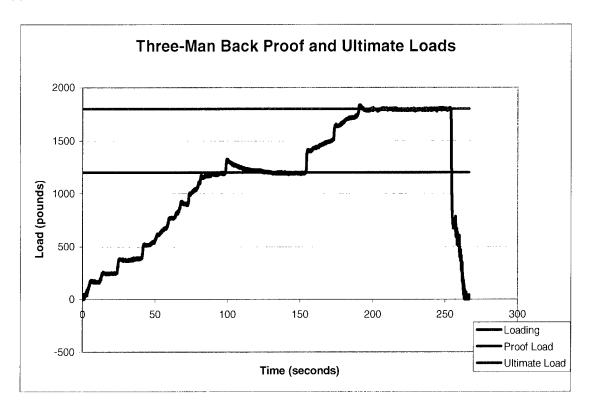
Figure 13: Data Collected during Testing of Seat Back

The second back test was conducted using a new seat. LT Tim Skaar was in attendance. Prior to attaching the seat to the Static Test Fixture, the seat was weighed and the weight was measured to be 8 lb. This seat was 3 lb heavier than the first seat that was back-tested. This test again used the three-man pressure foot. The proof load of 1,200 lb was first applied for 60 sec. Then the ultimate load of 1,800 lb was applied. There were no failures during this test. The graph created from the downloaded data is shown below in figure 13. All still photographs taken are available in appendix B.

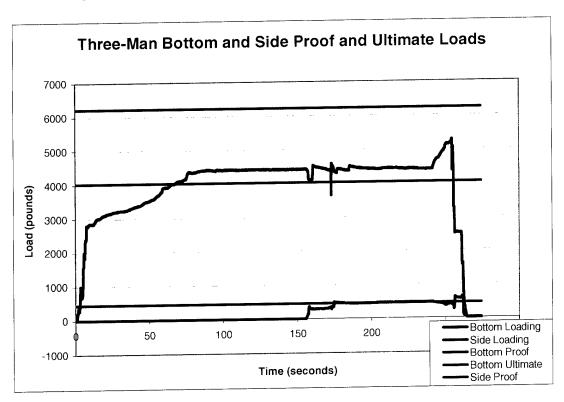
Figure 20: Data Collected during Testing of Seat Bottom and Side

The bottom and side test was the last test conducted. LT Tim Skaar was on hand to witness this test. The seat was weighed prior to testing and weighed 8 lb. The Test Plan called for a proof load for the bottom to be 4,410 lb. The loading was reduced to 4,030 lb to account for the weight of the pressure foot and the weight of the sandbags. This is because the seat would see the total weight of 4,410 lb, while the digital readout would only show 4,030 lb. The bottom load was first applied to the seat and held for 60 sec. After 60 sec, the displacement of the front tubing was measured and the side proof load was calculated to be 450 lb. This load was applied and, when reached, the right spreader bar came loose from the rear bar where it was attached. After consulting with LT Skaar, this was not deemed a failure and the testing continued. After holding the side proof load for 60 sec, the bottom load was increased so that the ultimate load of 6,220 lb could be reached. Prior to reaching the ultimate load at 5,420 lb, the legs of the seat buckled and the left spreader bar came loose from the rear bar where it was attached. It was

determined that the seat no longer had load-bearing capability and the test was stopped. Photographs of the failures are shown below in figures 14 through 19. The graph created from the downloaded data is shown below in figure 20. All still photographs taken are available in appendix B.

The three-man wall-hanging troop seat does not meet the standards established in Military Standard 5804C. Because they do not meet this standard, they do not give adequate protection to the troops that have to sit in them. Therefore, it is recommended that the seat be redesigned or that a replacement for the seat be found.
